# Proposal to Acquire and Restore the "Connecticut 1401"

Robert Garner, rev2, 2/2007

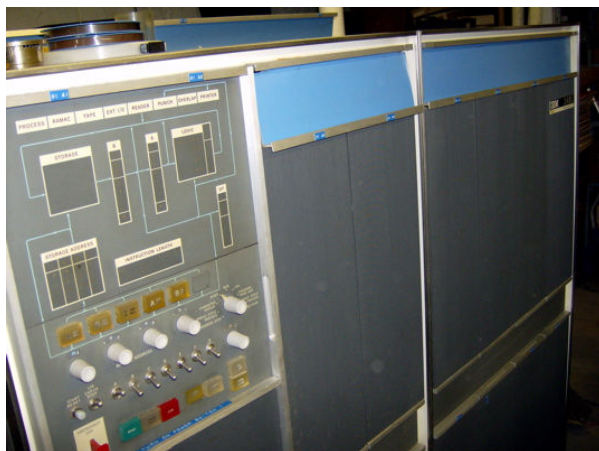
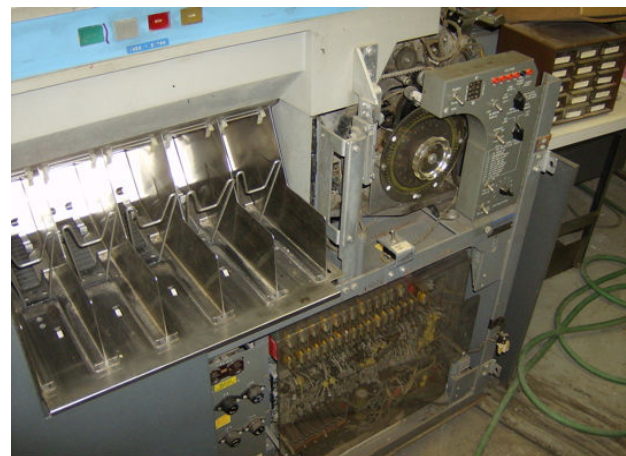
Figure 1b. 1401 CPU and 1402 Card Reader

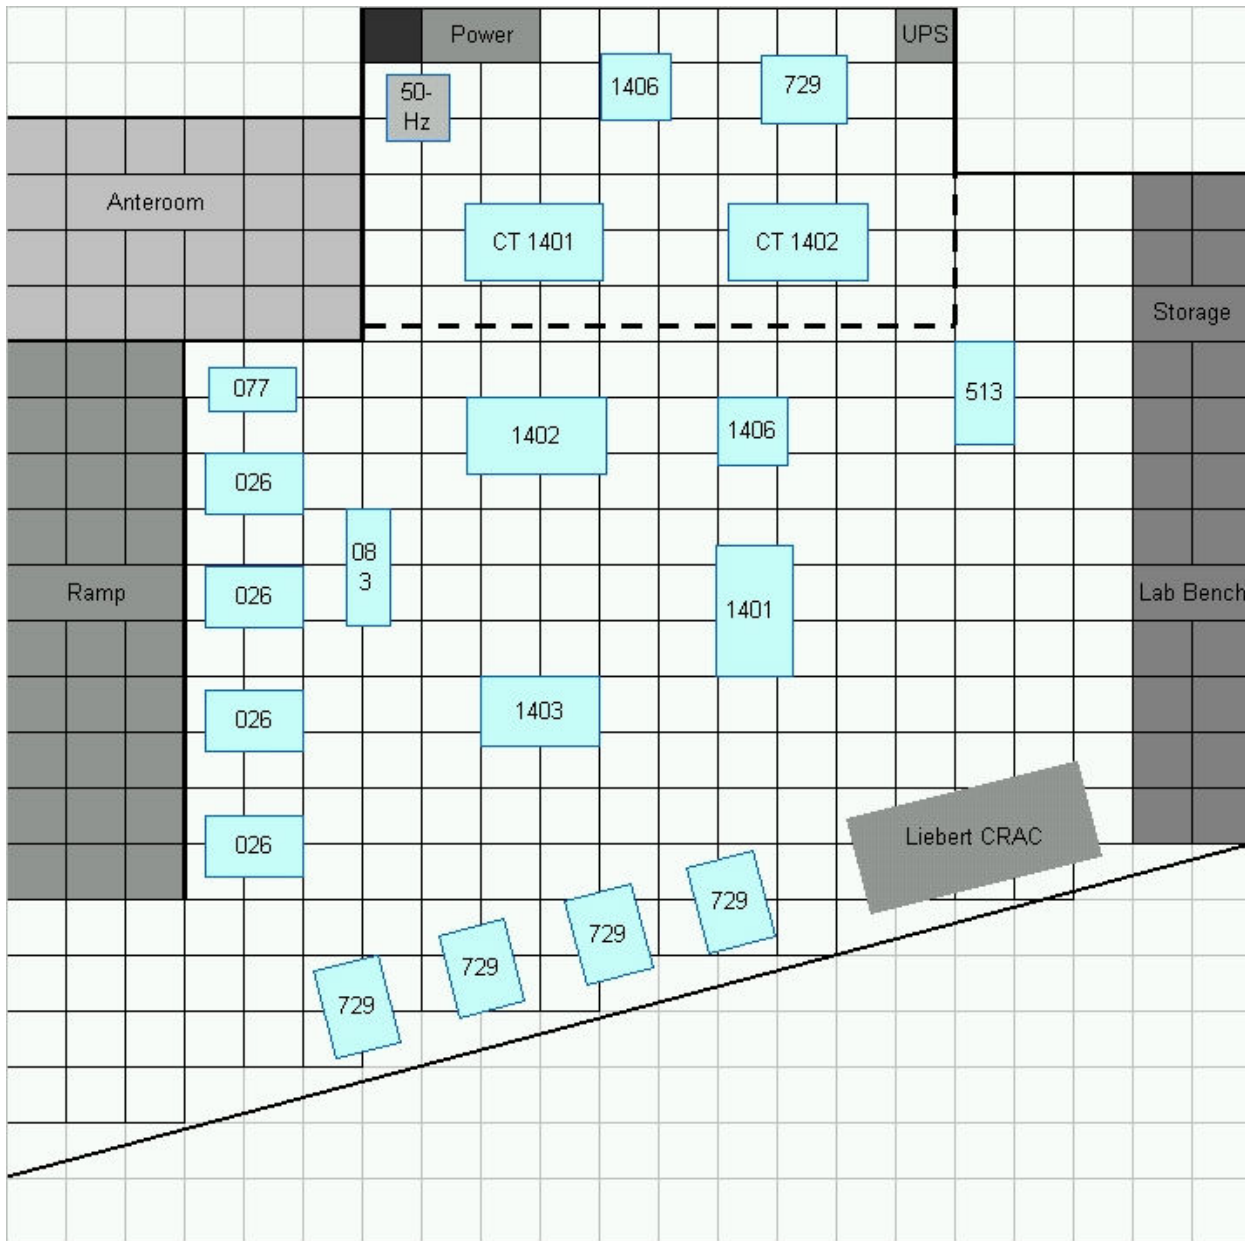
Figure 3: Proposed 1401 new restoration room floor plan:  
Accommodates all existing German units, main Connecticut units,  
and existing unit record equipment.

- 1) Inventory and copy all documentation and software.
- 2) As shown in Figure 3, free up and create an auxiliary restoration area in the 1401 room by removing the unneeded, redundant 30-ton Liebert System/3 Computer Room Air Conditioner (CRAC) and the now defunct EPC UPS system with lead-acid batteries. Current expectation is to sell or donate these large units. (Thanks to Stan Paddock for working on the arrangements.)
